Case Study

Avonmouth, Bristol

Challenge

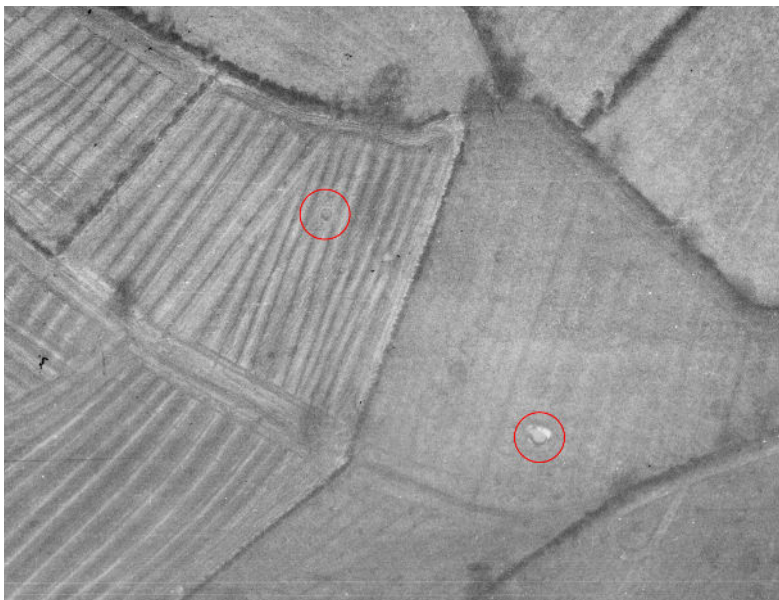
Aerial photography showing bomb craters on the development site in 1945.

A Detailed UXO Risk Assessment of the site area was undertaken and archival research found that two 250kg (HE) unexploded bombs (UXBs) were recorded in the south-western area of the site during the war – and that the area was also heavily affected by incendiary bombing during WWII.

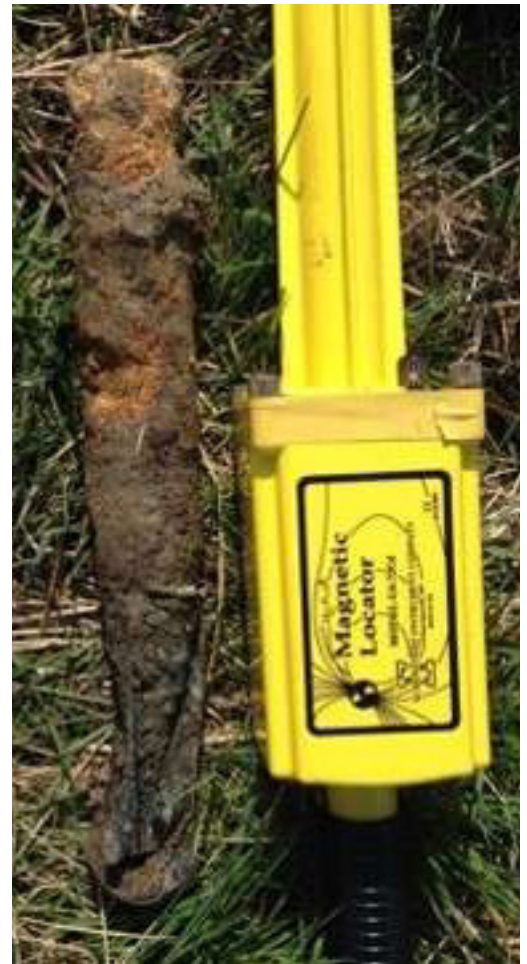
Image showing a partially expended 1kg German incendiary bomb unearthed on a development site at Avonmouth in Bristol.

The team recovered a number of partially expended 1kg German incendiary bombs, and the base of an anti-aircraft projectile. Pieces of shrapnel were also found in the areas of higher ferrous contamination, this might have been the remnants of the two 250kg UXB's – which were most likely destroyed in-situ.

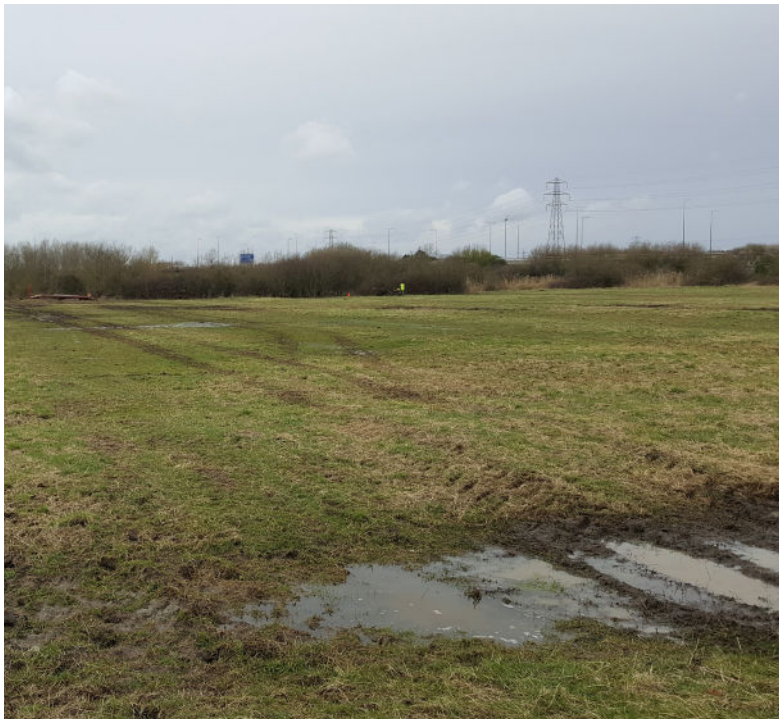
Image showing the site area that needed to be investigated for UXO contamination in Avonmouth, Bristol.

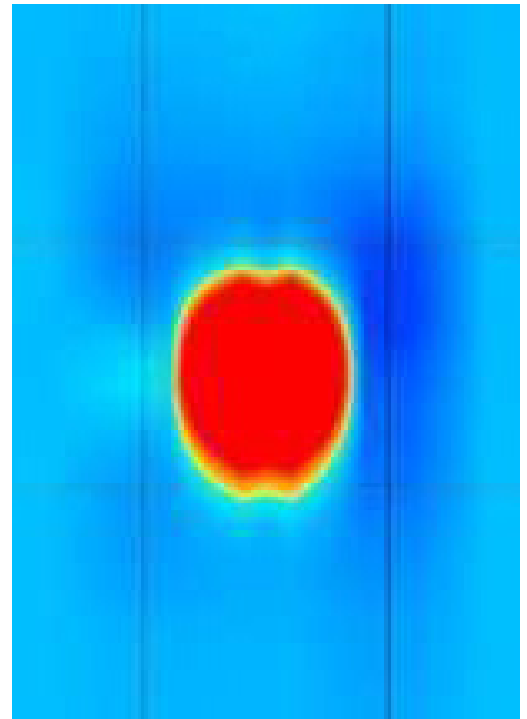
Image showing one of the anomalies which were identified from the Non-intrusive UXO Survey at Avonmouth in Bristol.

Following data processing / interpretation, a number of discreet anomalies were detected in the otherwise clean ground – including higher levels of contamination in the south-west corner of the site. A list of targets were modelled and selected for investigation by the Target Investigation team.

Target Investigation of these targets involved a two-man team (equipped with GPS positioning equipment and hand-held UXO detectors) to locate, excavate and inspect the anomalies in a controlled and safe manner.
