1ST LINE DEFENCE

Case Study

Nottinghamshire

Stage 1 – Detailed UXO Risk Assessment

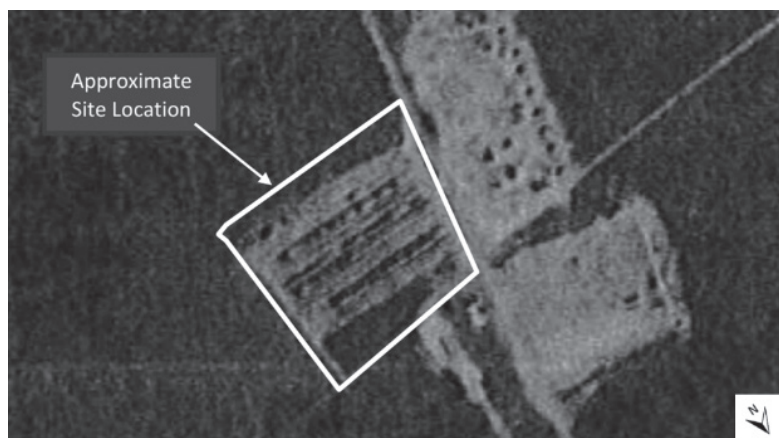
Image showing aerial photography of the site location and boundary, which highlights the burning/demolition pits – circa 1947.

1st Line Defence completed a Detailed UXO Risk Assessment in November 2020. The study confirmed that the site and the area to its west were historically utilised for ordnance demolition. Evidence of demolition trenches and pits were observed in aerial imagery from the late 1940's and early 1950's. The site location was still labelled as a 'Demolition Area' on military mapping from the 1970's.

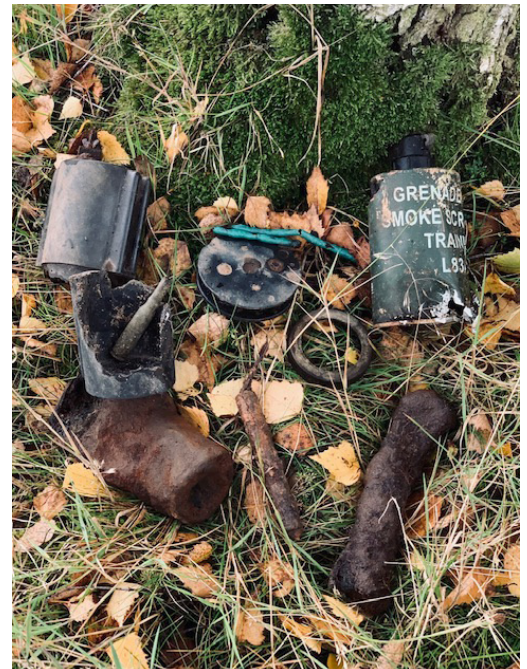
Image showing a used Smoke Grenade and other items of explosive ordnance found on-site during the first phase of UXO Watching Brief Support.

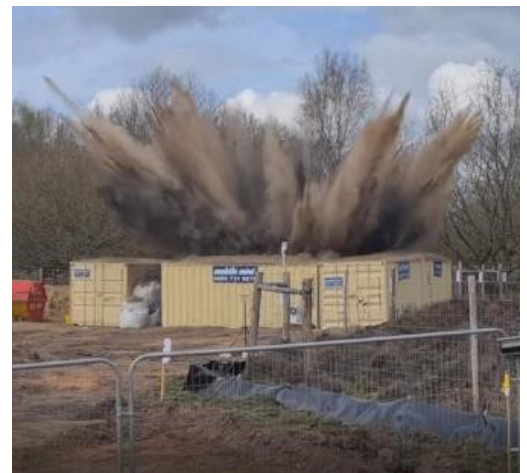
Example of one of the many ordnance detonation and disposal operations that were completed by 1st Line Defence.

Standard demolitions were undertaken using plastic explosives, with several detonations occurring on each scheduled demolition day. Each demolition was undertaken in accordance with the site-specific Explosives Management and Disposal Plan. This included strict safety cordons on demolition days to prevent members of the public accessing the area.

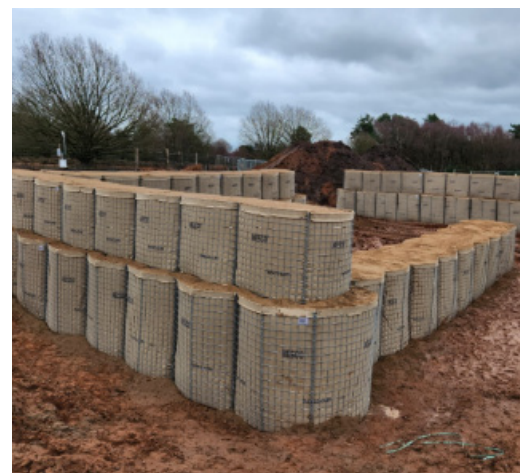
Image showing the HESCO Bastion blast protection installation which was used on-site in Nottinghamshire.

The relevant explosive storage licences were acquired, and a dedicated disposal area comprising sandbags and shipping containers was constructed. Alarmed and monitored explosives storage magazines were installed on site to hold the UXO finds and demolition explosives when required.

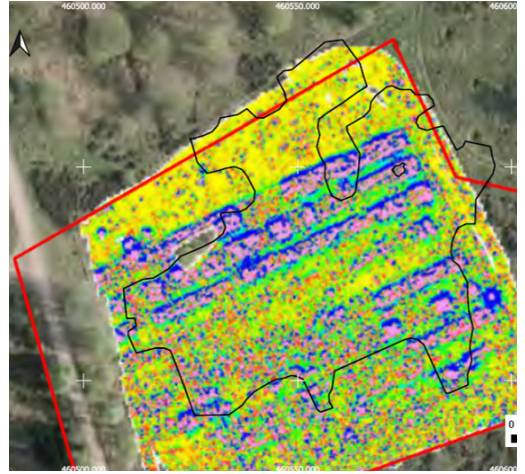
Image showing UXO contamination before remediation work had started in Nottinghamshire.

The data collected in 2023 (shown middle right) was compared to a survey undertaken on-site in 2015 (shown top right), and confirmed that the area of the burns pits had been successfully cleared / remediated. The annotated false-colour overlay below shows the results in more detail, with annotations showing various site features.

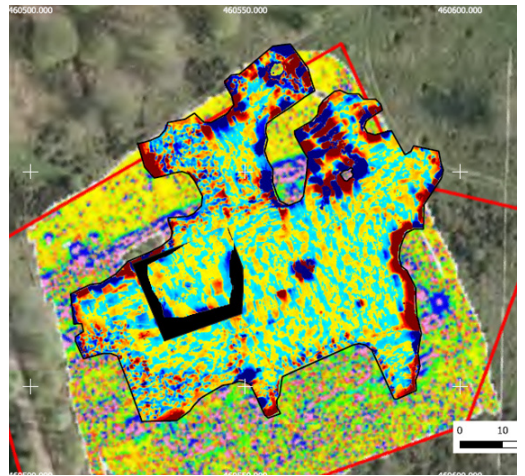
Image showing UXO contamination levels after the project was completed in Nottinghamshire.

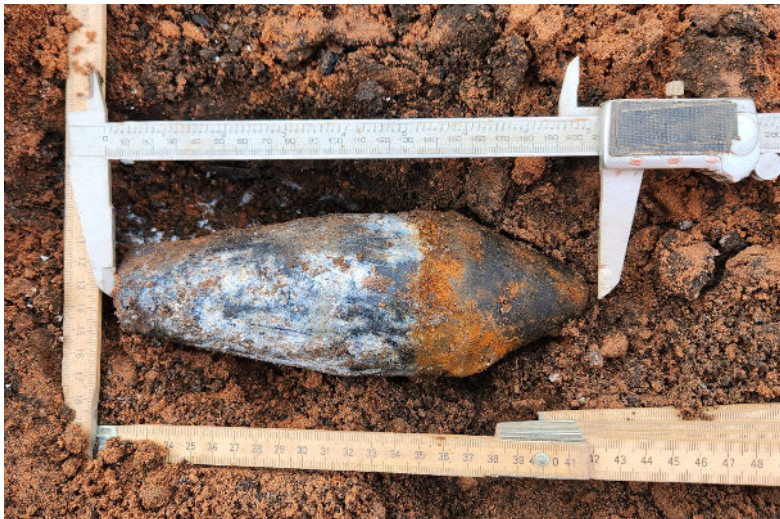
Example of explosive ordnance found by 1st Line Defence in Nottinghamshire.

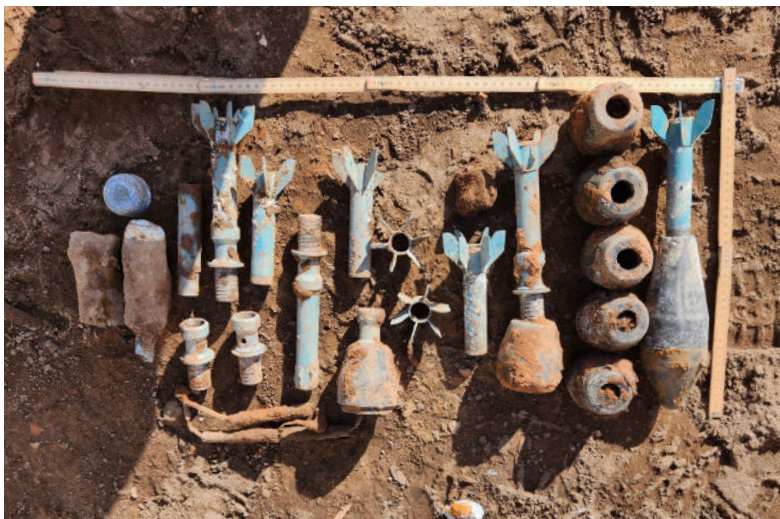
Examples of LIVE explosive ordnance found by 1st Line Defence during excavation works in Nottinghamshire.

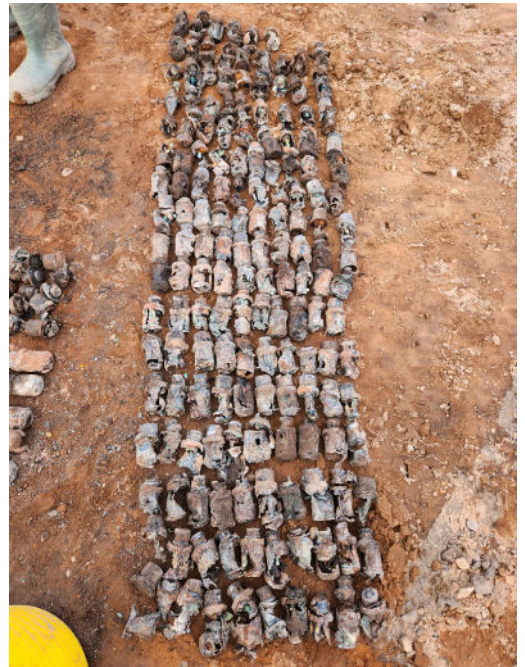
Image showing detonated 2-inch Mortars found during excavation works in Nottinghamshire.
