# Case Study Thetford, Norfolk

# Challenge

In December 2015, 1st Line Defence were commissioned by Norfolk Wildlife Trust to provide <u>UXO Support</u> at a site near Thetford in Norfolk to determine whether any UXO contamination may be present prior to construction work commencing to develop a new culvert.

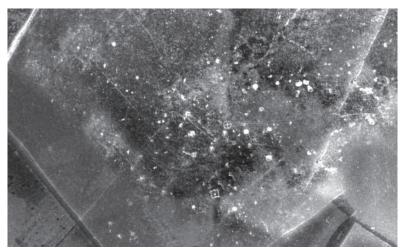
Image showing aerial photography of the Thetford area in 1945, with obvious signs that a bombing range was previously active in the main works area.

Preliminary research was undertaken by our in-house Research team which showed the site area was part of a WWII-era practice bombing range. Therefore, there was a potential risk of UXO contamination from Land Service Ammunition (LSA), Practice Bombs, and other types of explosive ordnance that may have been used during training exercises.

Because of previous use and history of the main works area, the site was assessed to be at a 'High-Risk' of UXO contamination being present, and additional UXO risk mitigation was recommended.

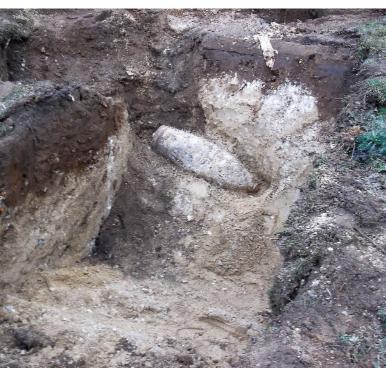
Image showing a British 500lb HE unexploded bomb during excavation operations at a site in Thetford. Norfolk.

At the end of the operation a total of 63 UXO-related items were recovered, these included 'live' 3-inch HE mortar rounds and a 'live' British 500lb unexploded bomb

The 'live' 500lb unexploded bomb and Mortar rounds were destroyed in-situ by the Ministry of Defence (MoD) and any Free From Explosives (FFE) or ordnance related scrap materials were safely disposed of by 1st Line Defence.

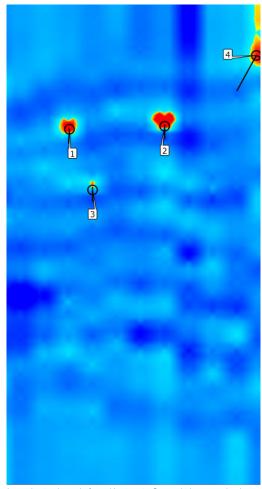
lmage showing the results from a Non-intrusive Survey which was completed at Thetford in Norfolk

A two-man team surveyed the main works area and the data was sent to our in-house Geophysical team for processing and interpretation. A false-colour map was produced which showed a number of sub-surface ferrous anomalies which were recommended for further investigation.

A number of targets were identified and modelled, and a selection were inspected by our Target Investigation team.

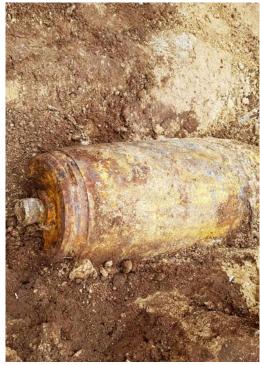
Close-up image of a British 500lb HE unexploded bomb found during Target Investigation at a site in Thetford, Norfolk.
